# *Tornado Damage Assessment Report*

SUBJECT: Tornado Damage Assessment Report, Southern Region

# **RESULTS OF URBAN TORNADO DAMAGE ASSESSMENT** **IN CHARLES COUNTY, SOUTHERN MARYLAND**

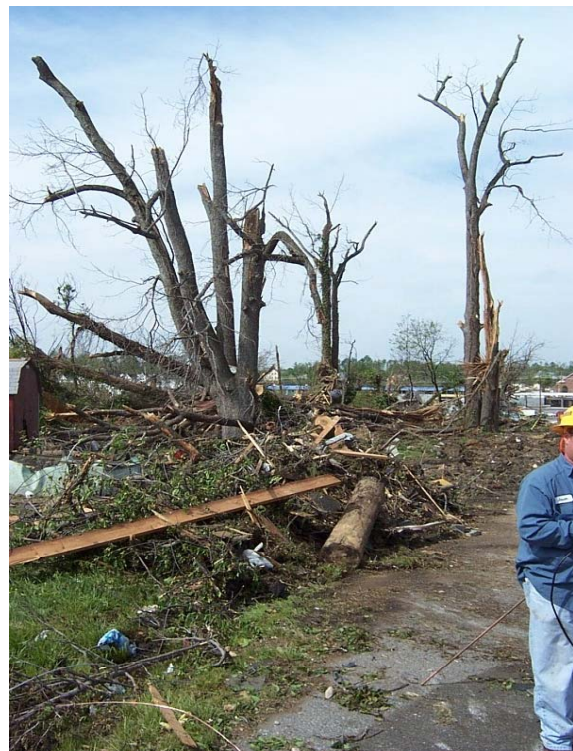
Figure 1. Complete Loss of Apical Dominance. [Polygon #1; E6, Baltimore Street]

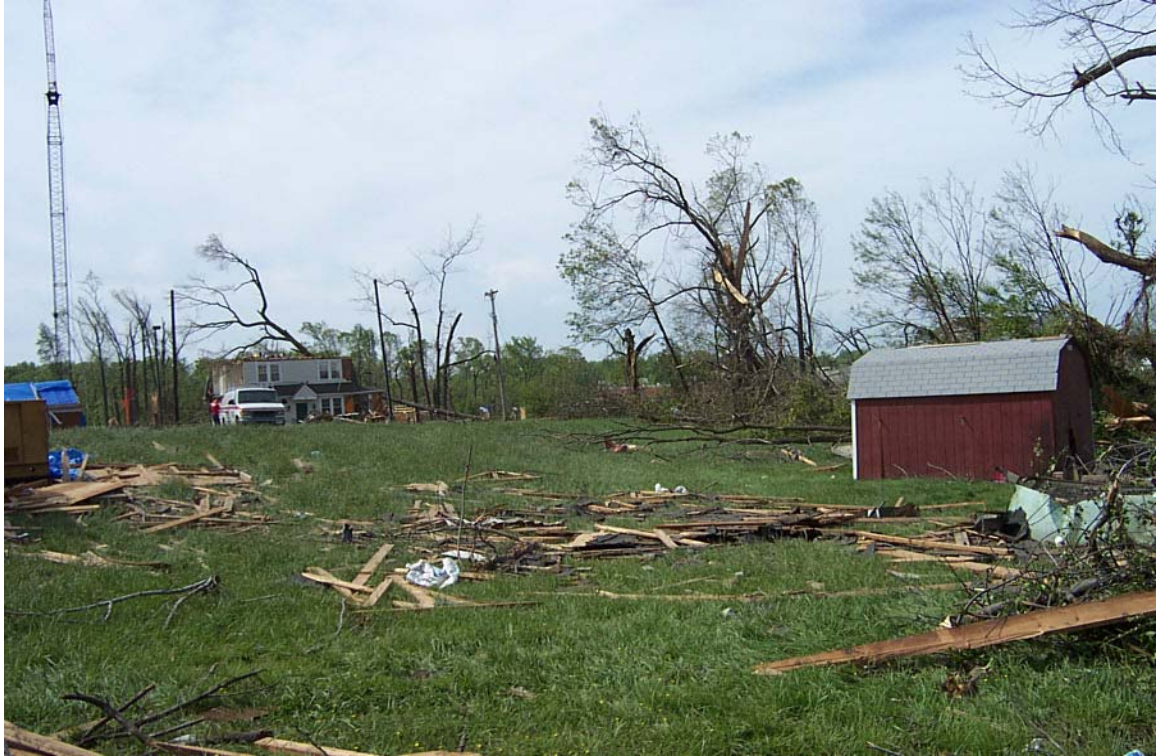
Figure 2. Extreme Tree Damage to Roots, Boles and Branches. [Polygon #2; E6-E7, Howard]

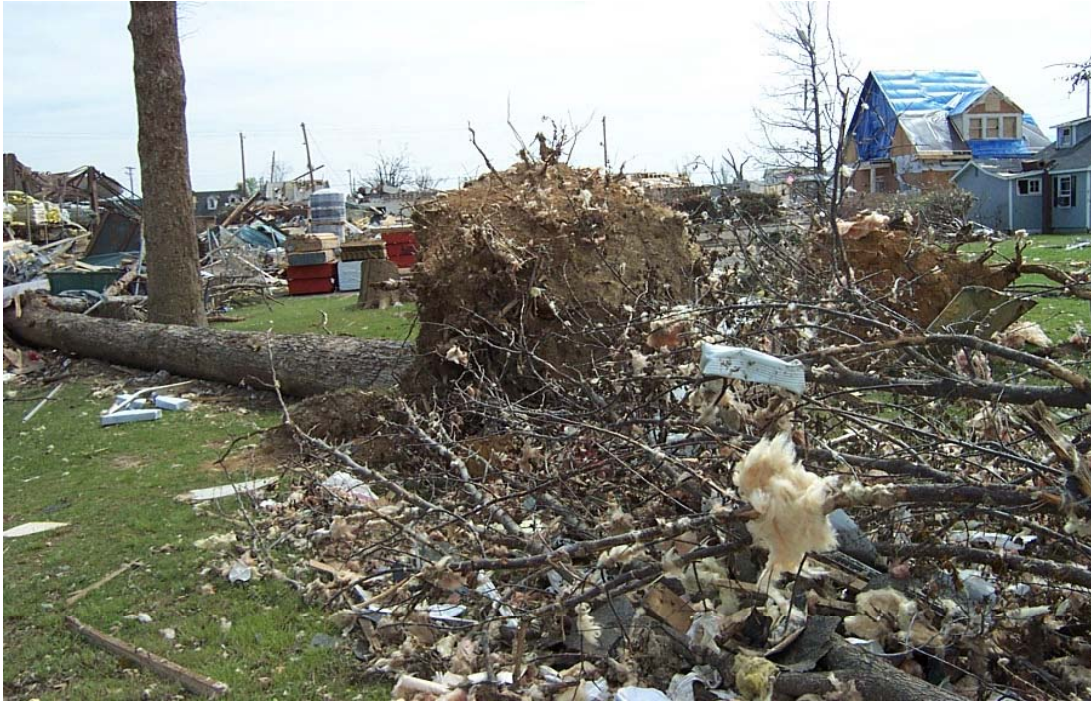
Figure 3. Widespread Tree Damage (Polygon #2; E6 – E7, Howard)

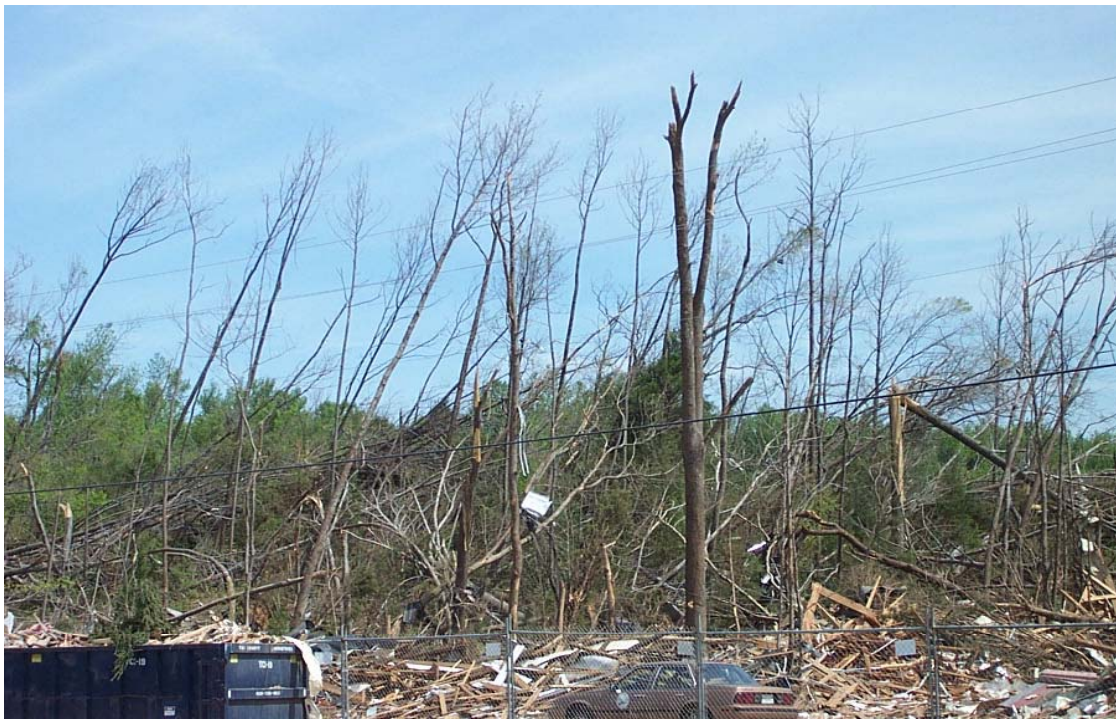
Figure 4. Completely Uprooted Trees. [Polygon 3; E7, Centennial Street Area]

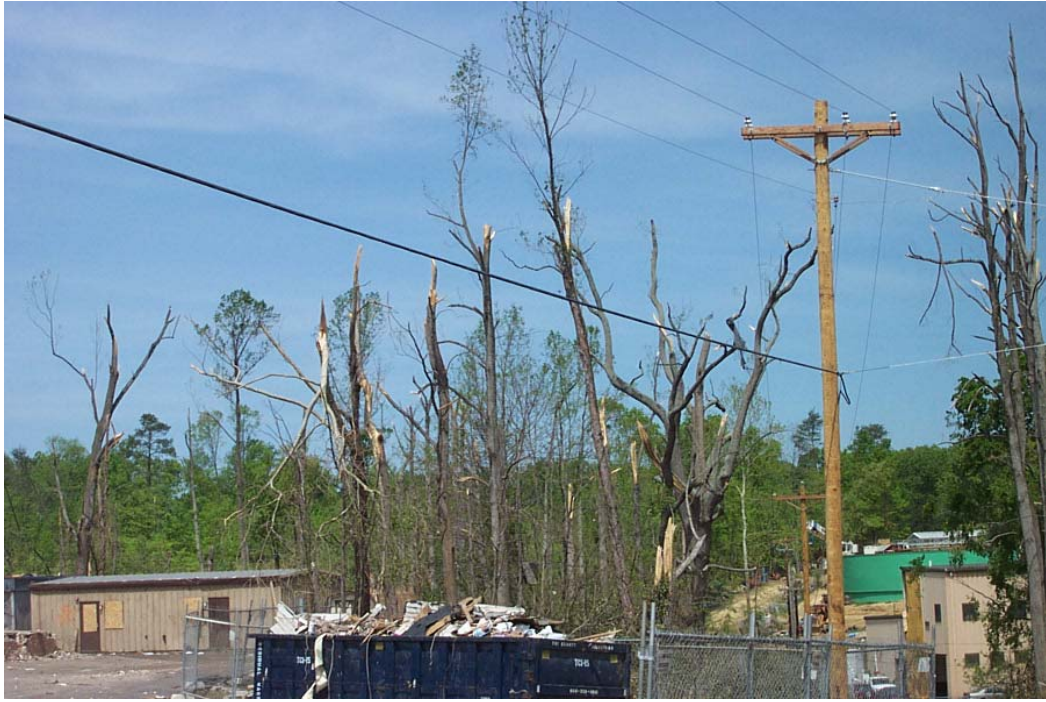
Figure 5. Complete Defoliation, Broken Branches, etc. [Polygon #4; D6,  
Near La Plata Shopping Center]

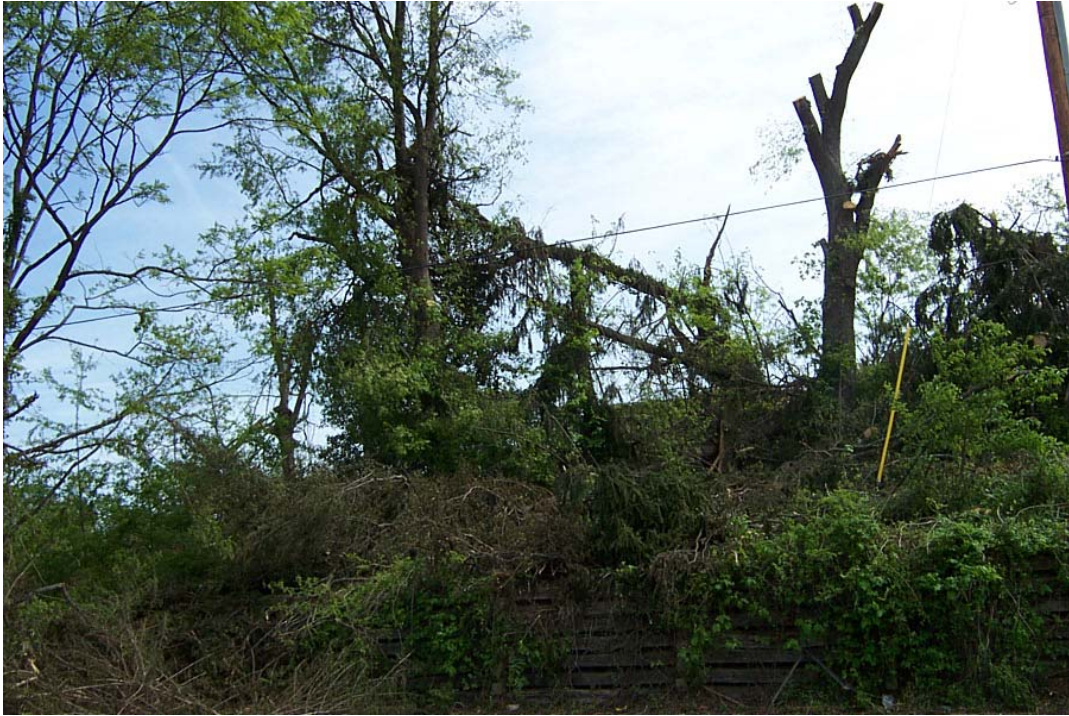
Figure 6. Broken Boles and Loss of Apical Dominance. [Polygon #4; D6,  
Near La Plata Shopping Center]

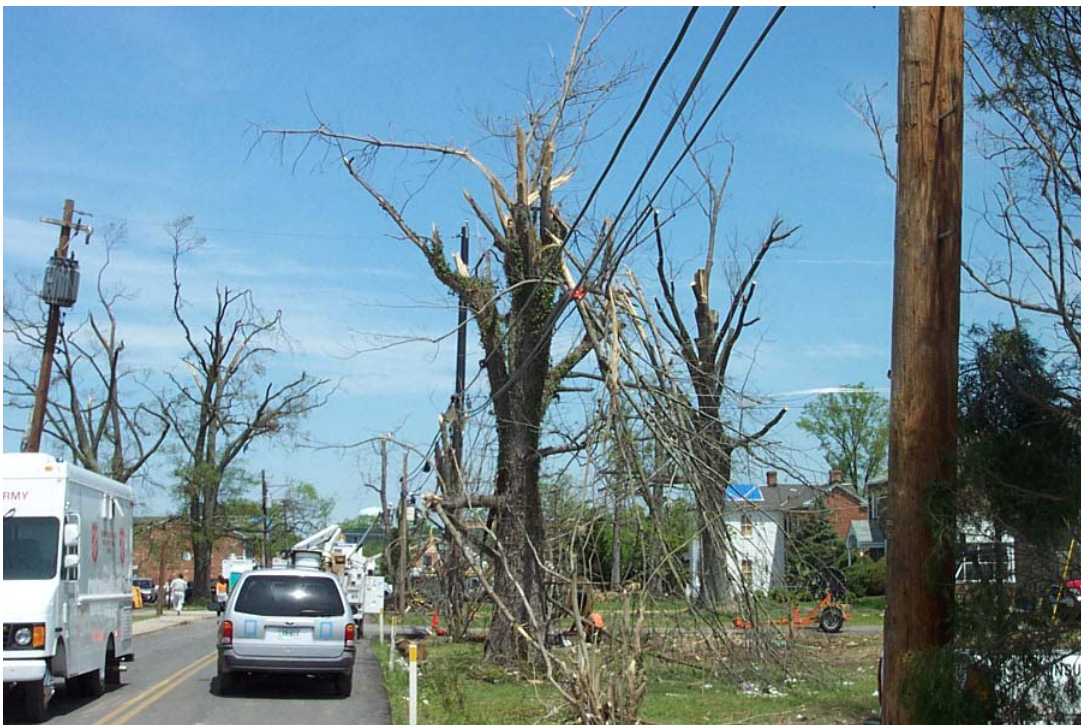
Figure 7. Broken Branches. [Polygon #5; D6, Charles County Gov't. Blds.]

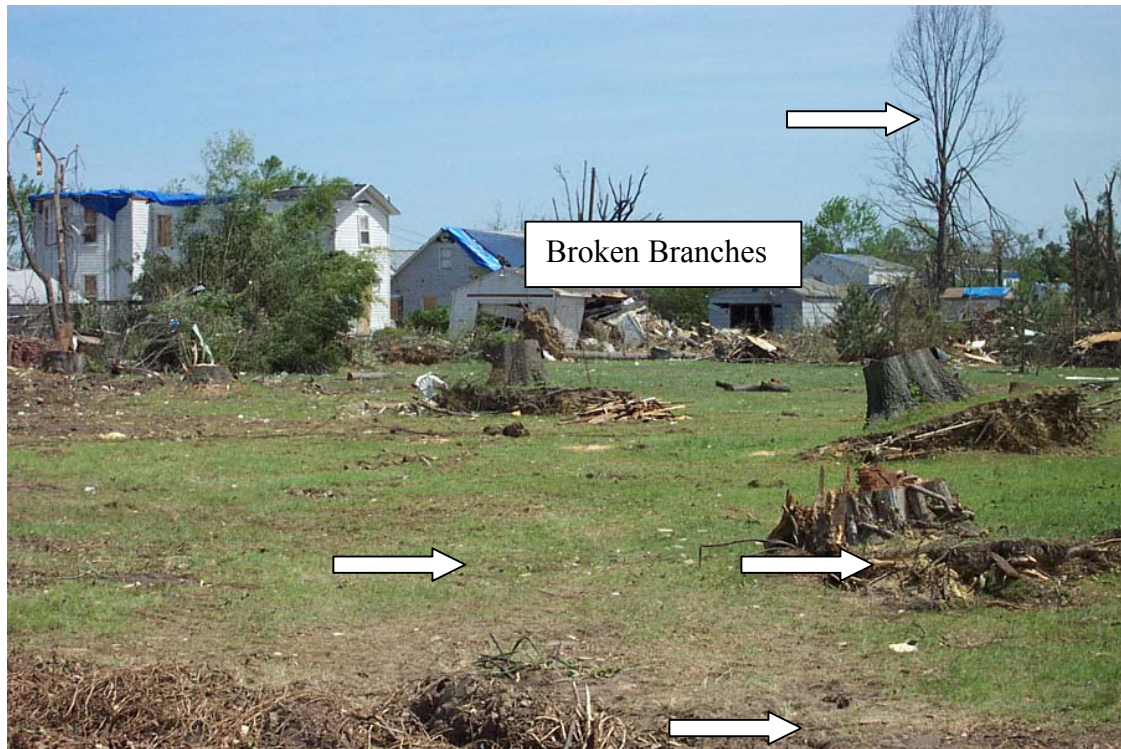
Figure 8. Massive Crown Damage to Trees. [Polygon #6; F7, Oak Avenue]

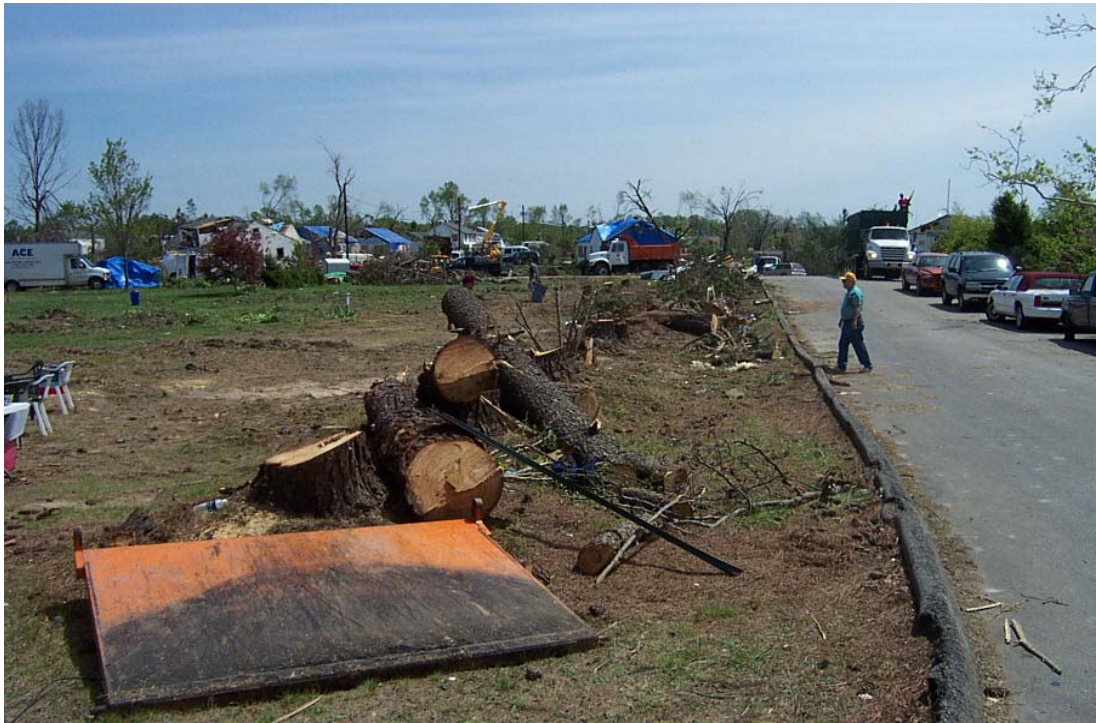
Figure 9. Partial Uprooting and Subsequent Felling of Trees. [Polygon # 6; F7, Oak Avenue].

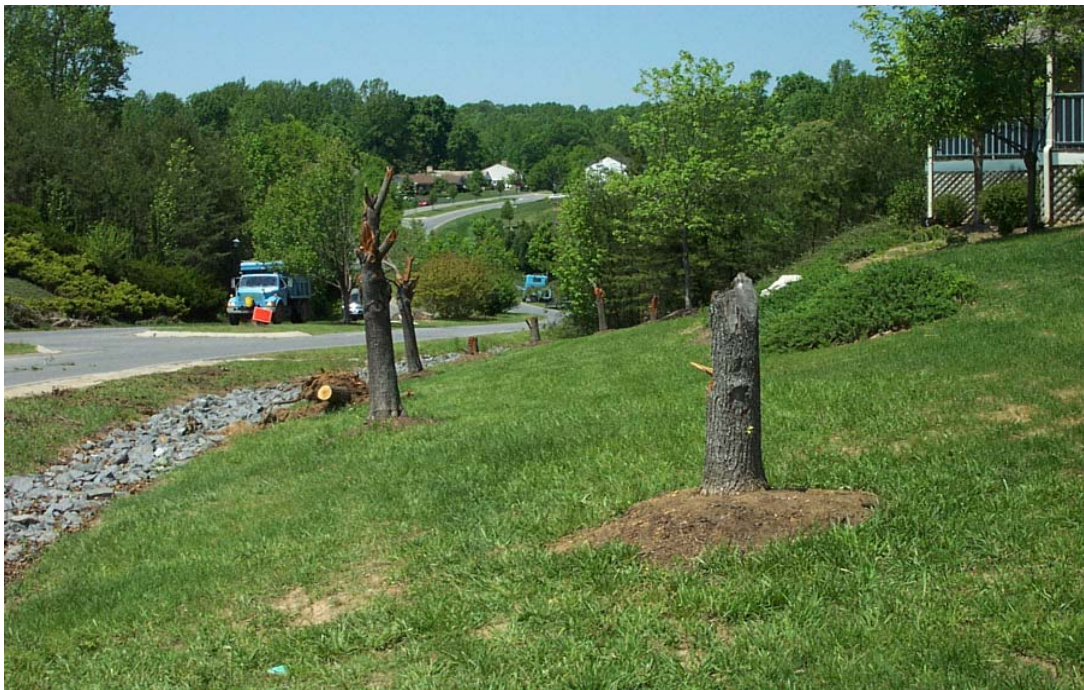
Figure 10. Roadside Trees Removed. [Polygon #6; F7, Worcester Street]

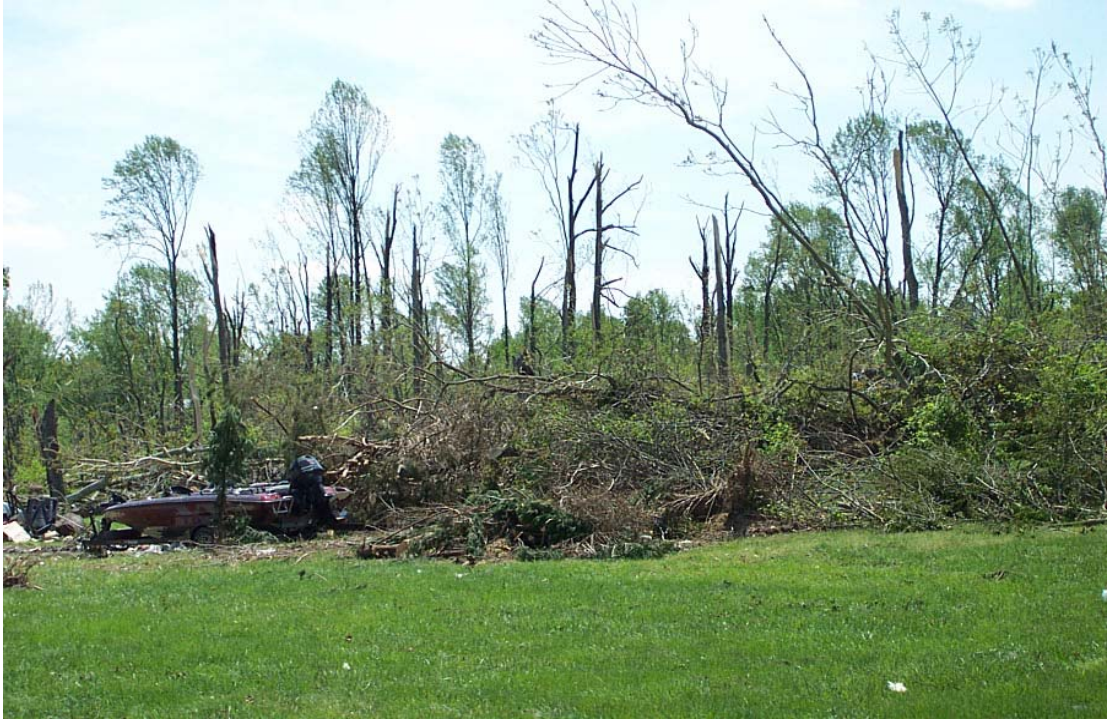
Figure 11. Broken Boles – Trees Subsequently Cut. [Polygon #7; C6, Quailwood]

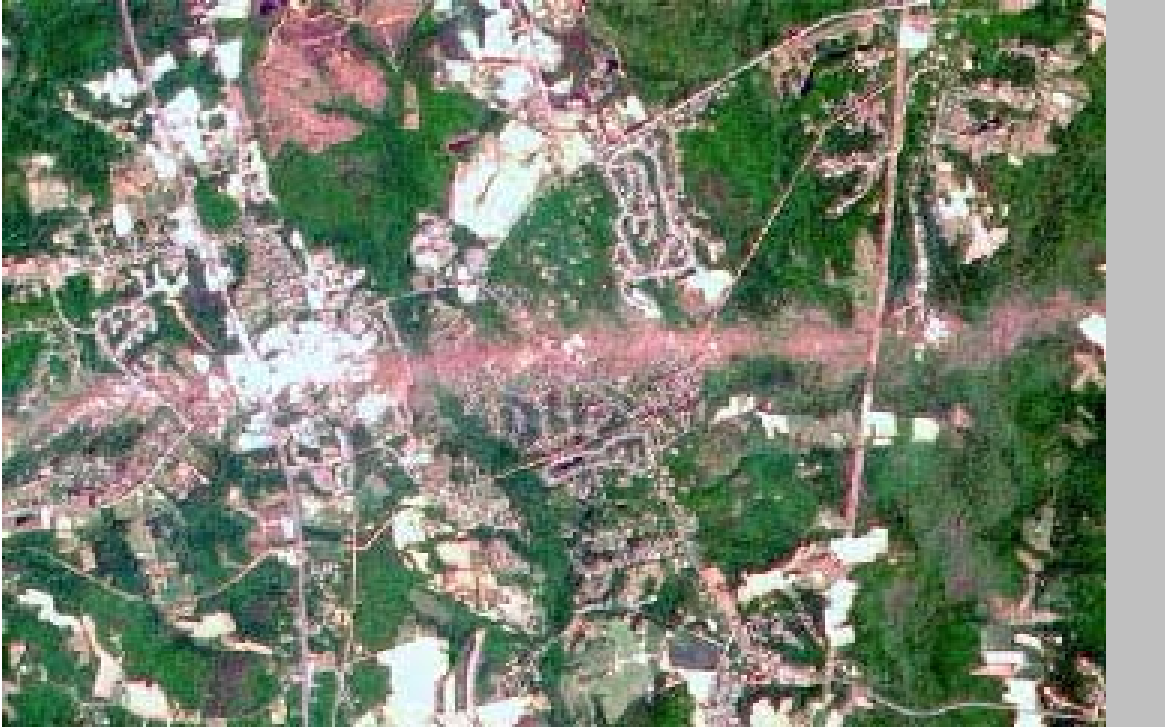
Figure 13. Panoramic View of Tornado Damage. [E7, Centennial Street Area.]
